# The 156-tonne GIMLI GLIDER

It's the 20th anniversary of aviation's most famous deadstick landing.

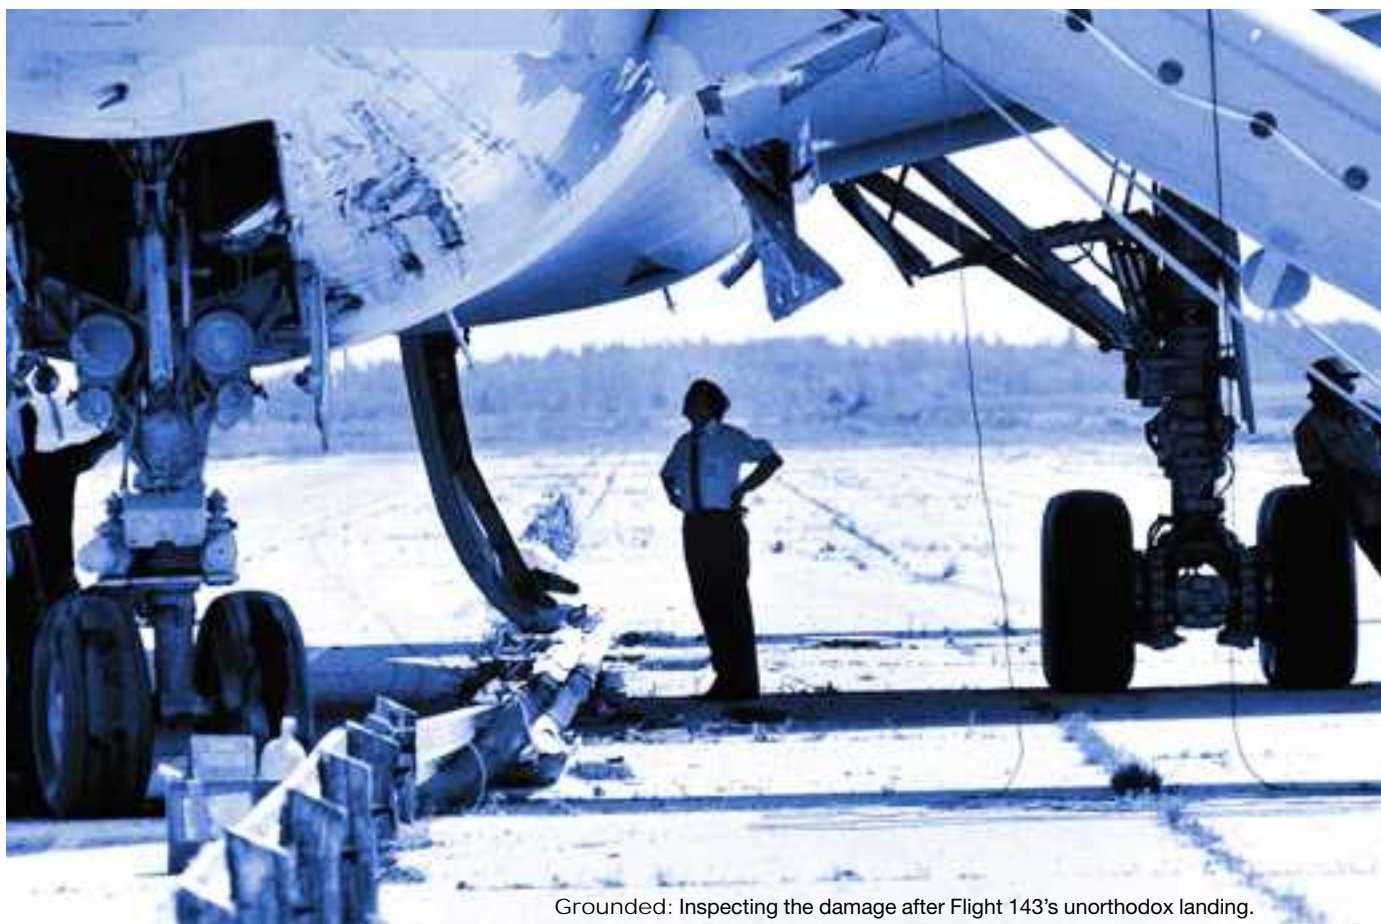
Grounded: Inspecting the damage after Flight 143's unorthodox landing.

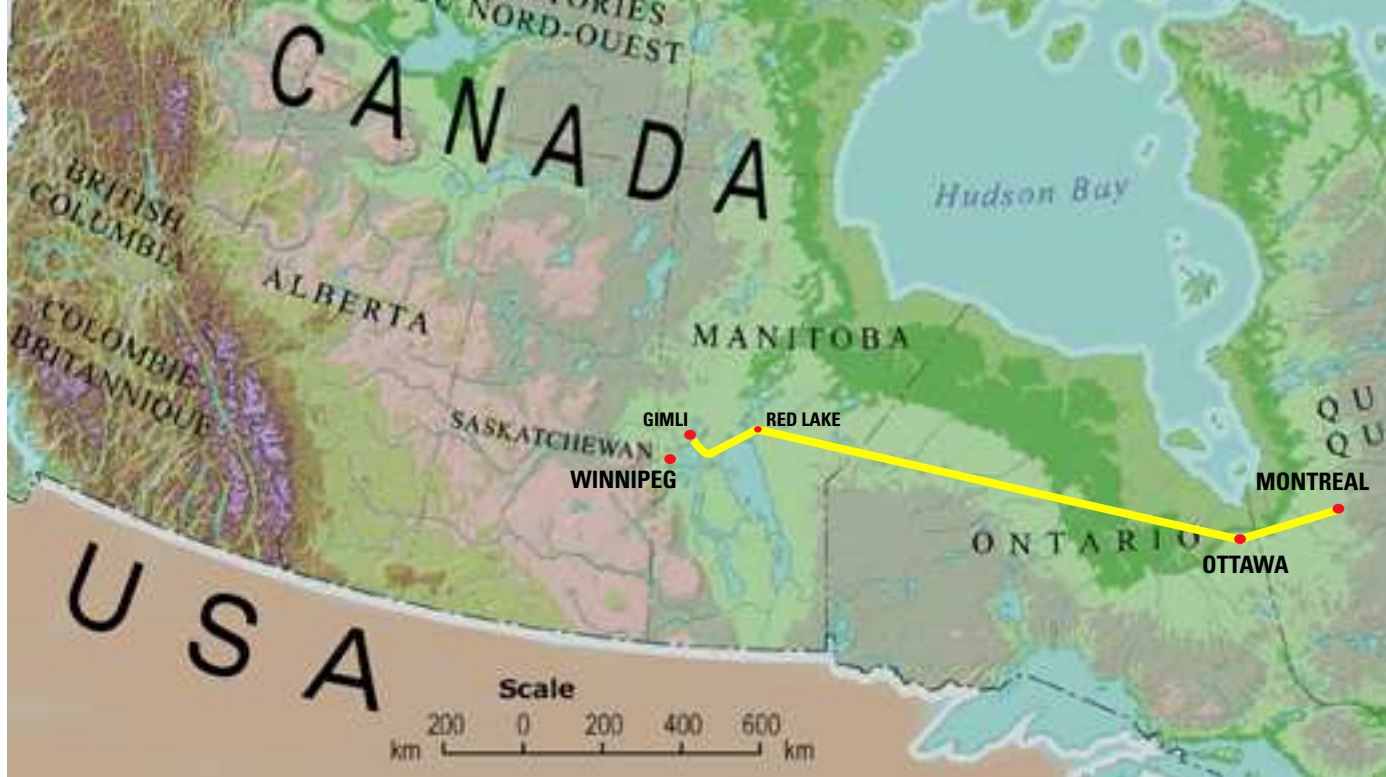
Cut short Travelling from Montreal to Edmonton via Ottawa, Flight 143 was forced to divert to Winnipeg because of a fuel shortage that led to the loss of both engines. When it became apparent the aircraft would not reach Winnipeg, the pilots changed course and headed to Gimli.

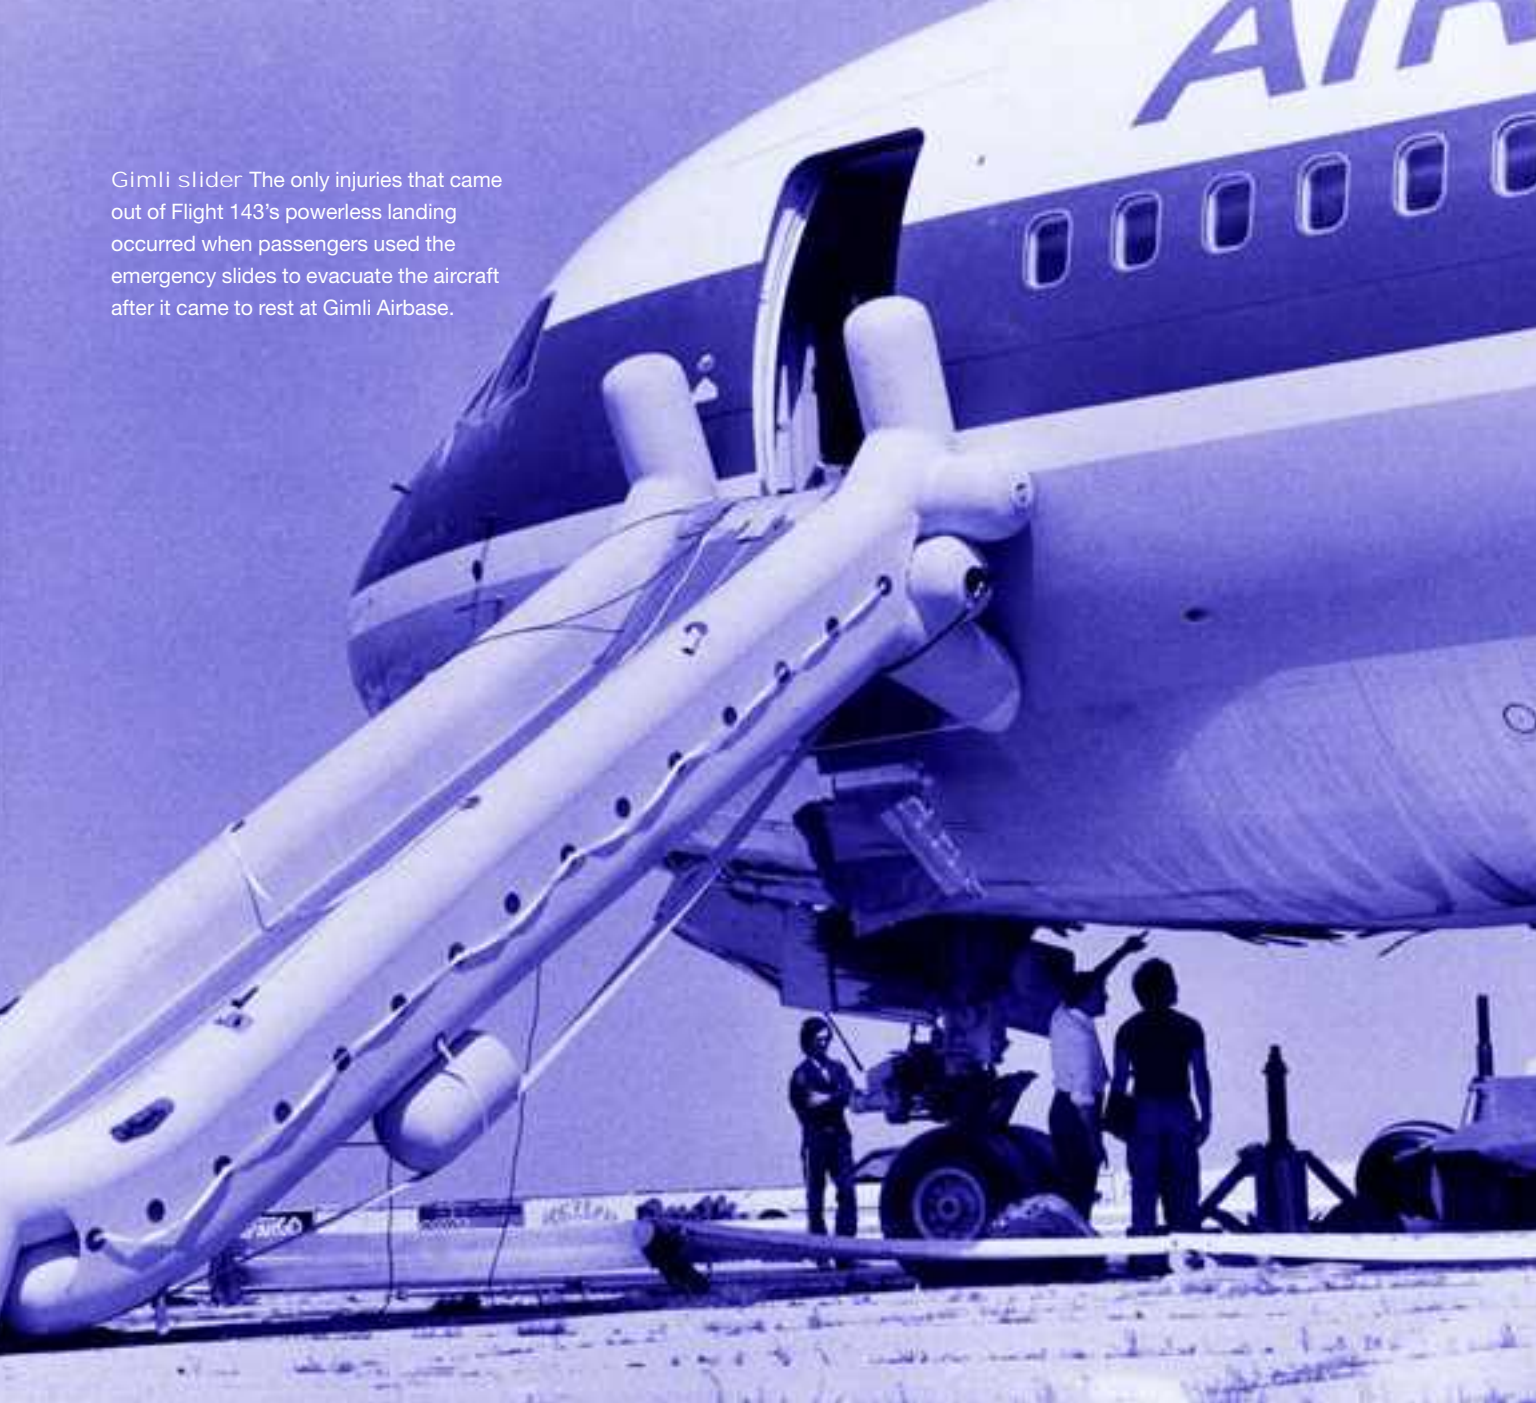
**Gimli slider** The only injuries that came out of Flight 143's powerless landing occurred when passengers used the emergency slides to evacuate the aircraft after it came to rest at Gimli Airbase.
